Restoring stream aquatic fauna: facilitating natural processes

Peter Ardill, Lawson Bushcare and StreamWatch, AABR accredited practitioner

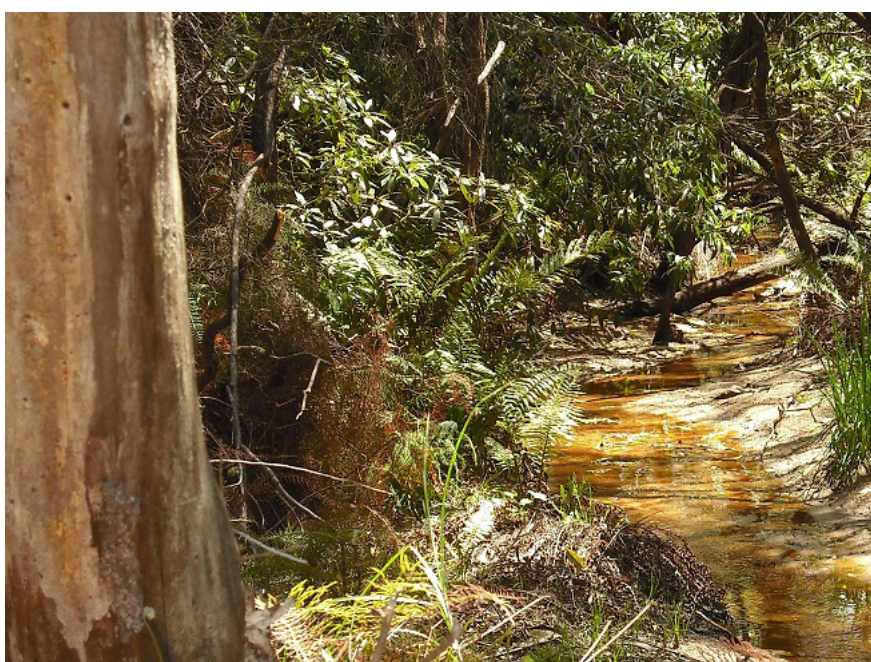
Image 1: Silted Lawson Creek 2010

controls on a building site. A long section of healthy bushland creek was reduced to a shallow trickle of water (Image 1). More than a decade of previous systematic volunteer StreamWatch² and professional aquatic surveys had recorded a wide range of aquatic fauna species in the stream, but they and their natural habitat, such as logs, leaf litter, pools, riffles and aquatic vegetation, were gone.

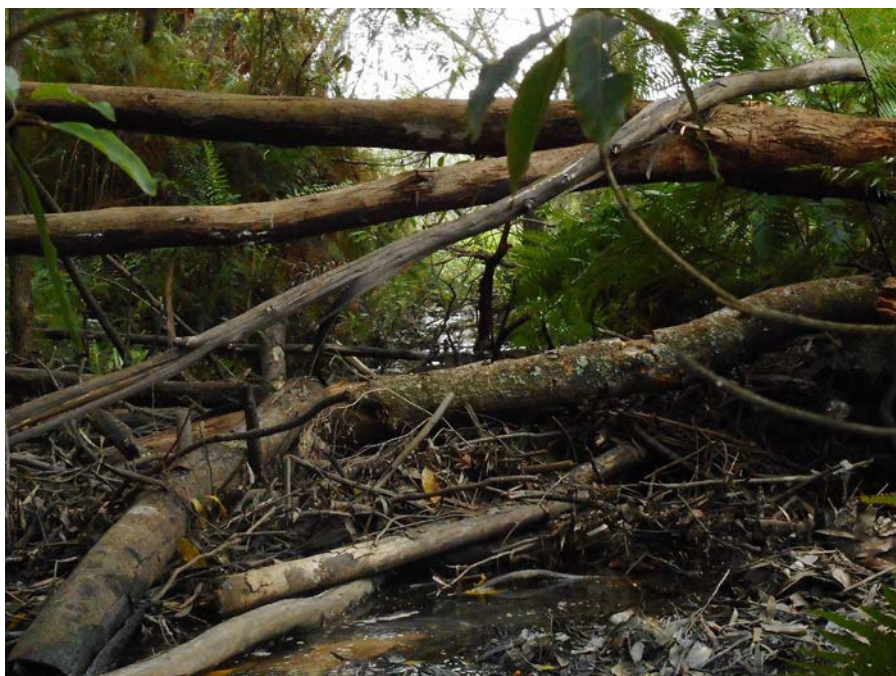
Image 2: Natural debris in previously silted section Lawson Creek 2018
Photo: P Ardill

Nevertheless, the stream remained heavily silted for a number of years, and it was only in 2015 that the volunteer StreamWatch Group recommenced water quality testing (not bug testing, as there was still no bug habitat) along the damaged section of stream, with good results: the water had appropriately low levels of salt and phosphates, was well oxygenated, chemically balanced and clear. Due to the increasing layers of decomposing natural debris, the deposited sand and sediments were continuously being spread over an increasing area of the riparian zone and gradually became vegetated. By 2018 the creek was starting to resemble its former healthy condition, displaying a few deep pools and small rapids, some good natural habitat of decayed logs, other fallen timber, and a layer of leaf litter along the banks and channel (Image 2).
